ROOF DESIGN & CONSULTING SERVICES, INC.

## Red Algae and WHITE Roofs

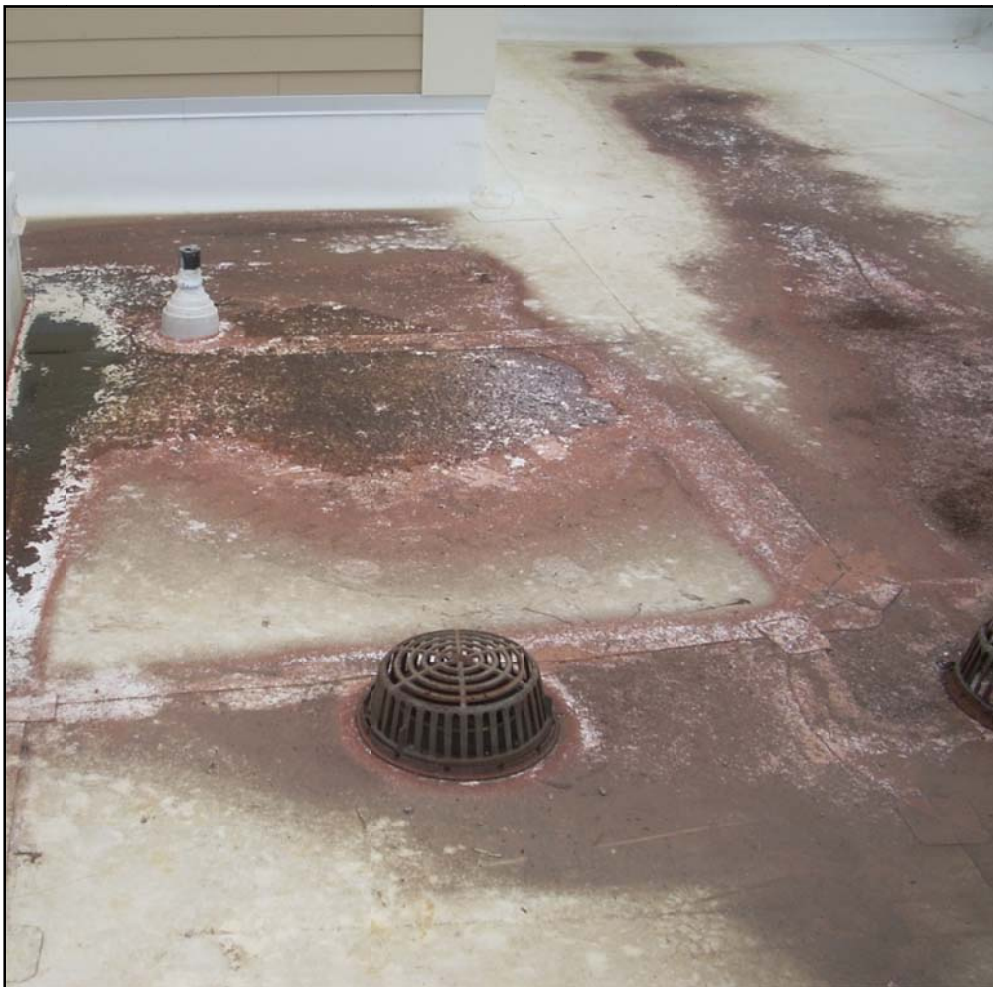
Red Algae growth on Thermoplastic membrane  
October 2013  
Roof installed June 2013

In conclusion, however, the best preventative is an adequately sloped roof surface. If water does not accumulate, there is no medium for algae growth. Remember, code and manufacturer requirements for roof slope are absolute minimums, so it certainly is possible (even preferable) to exceed these minimums and ensure that no standing water is present.
